# Corrosion Induced Loss of Capacity and Development of a Guided Wave Condition Assessment Method for Multistrand Anchor Systems Used in Corps Projects

Richard W. Haskins, James A. Evans, and Robert M. Ebeling

August 2014

Final report

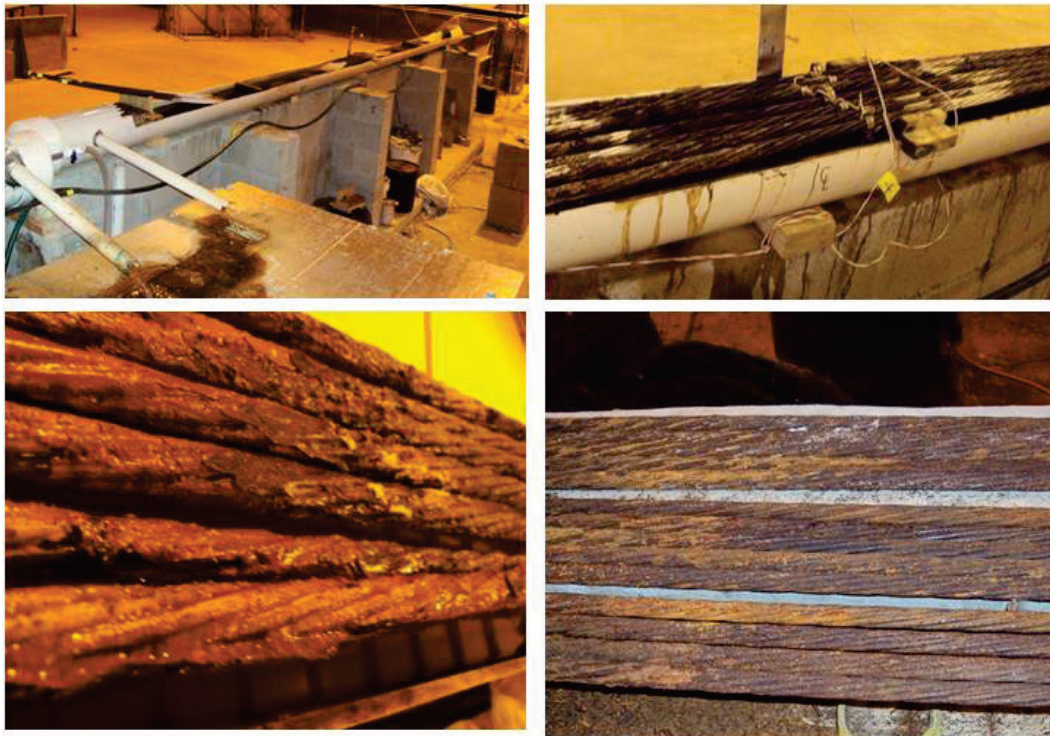
Figure 2. Photographs of corrosion tanks and corroded seven strand wire cables.

The cables within the corrosion tanks (Figure 2) were continuously monitored, along with the fluids, temperature, and current flowing through the system.

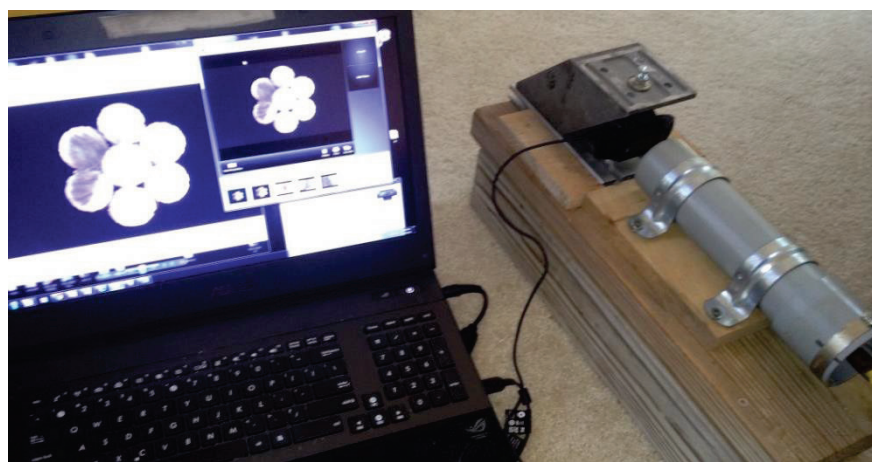
Figure 11. Computer capture with cable installed in imaging frame.

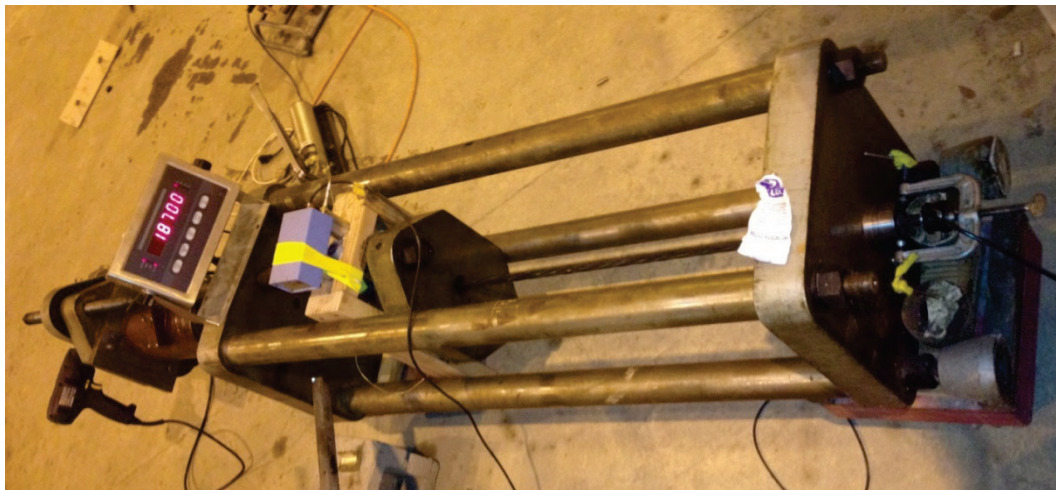
Figure 42. Small hydraulic load frame with fine control of applied tension.
